**TIMBER IN THE BUILT HERITAGE CONFERENCE – 17 + 18 OCTOBER 2002**  
**Historic Scotland, The Hub, Castle Hill, Edinburgh, Scotland**

## **Designing out Timber Deterioration: Environmentally Sustainable Conservation Solutions**

Dr Jagjit Singh BSc MSc PhD CBiol FIBiol FRSH FRSA  
Director  
Environmental Building Solutions Ltd.  
T 01525 261922 F 01525 261923 [ebss@ebssurvey.co.uk](mailto:ebss@ebssurvey.co.uk) [www.ebssurvey.co.uk](http://www.ebssurvey.co.uk)

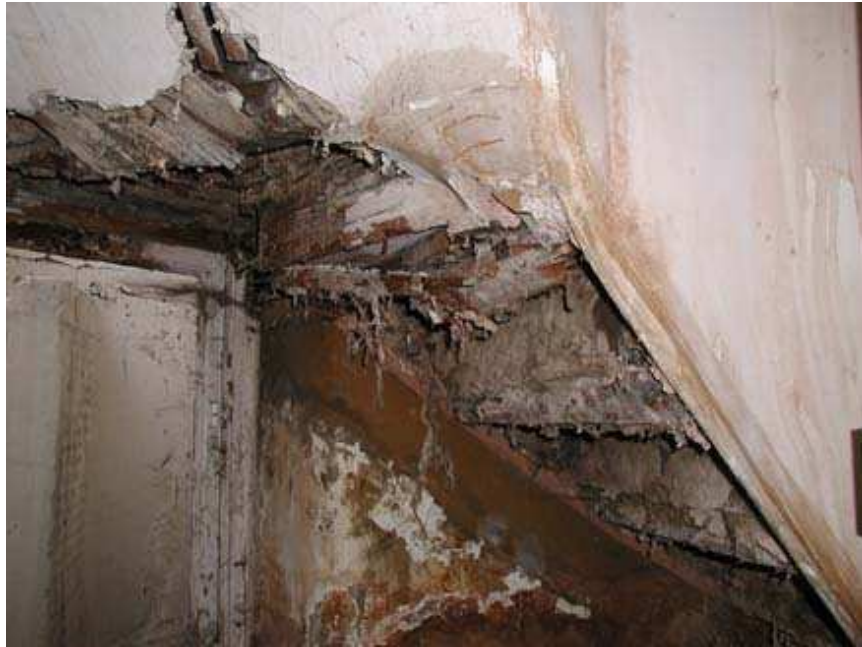
## Photograph 1

***Extensive timber decay caused by dry rot (Serpula lacrymans)***

Timber in historic buildings, abbeys, churches, timber frame buildings, barns, castles, jetties, bridges and other structures is inherently susceptible to fungal and insect infestation and decay, if it is not well designed, kept dry and well ventilated. Once the infestation has started it will continue to propagate, if the conditions are favourable, until eventually the timber member can no longer sustain loads (see photograph 1).

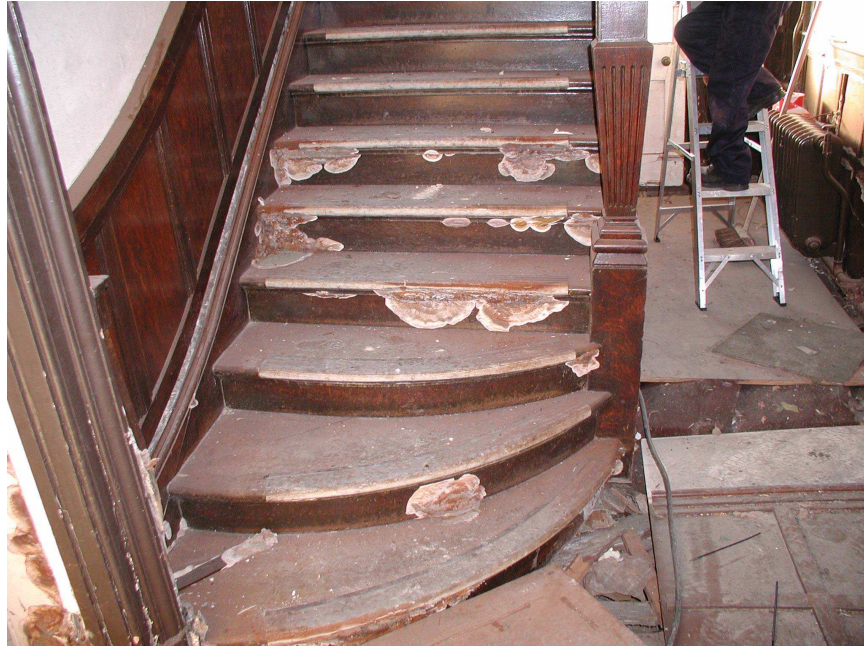
### **Photograph 2**

**Dry rot fruiting bodies to timber staircase, causing extensive structural damage.**

The ravages of the dry rot fungus are familiar (see picture 2), as is the destruction caused by attempts to eradicate it, particularly involving the use of chemicals.

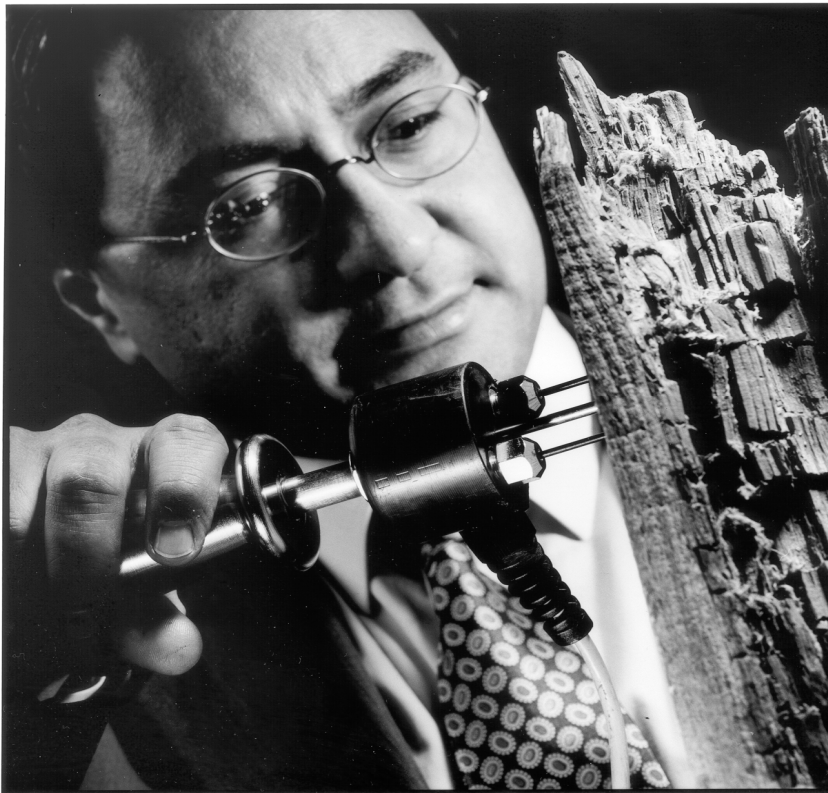
### **Photograph 3**

**Dr Jagjit Singh using hammer probe to measure deep moisture content of timber.**

Other techniques used included microscopy, laboratory culture and identification of fungi and insects, hot wire anemometry and electronic moisture and RH measurement(see photograph). More exotic techniques may sometimes be useful such as infra-red thermography, short wave radar, automatic weather stations, ultrasonic detection of timber and total building monitoring using specialist data loggers. It is important to remember that any technique must be carefully justified because the value of the information from techniques not routinely used or properly calibrated can be very limited.

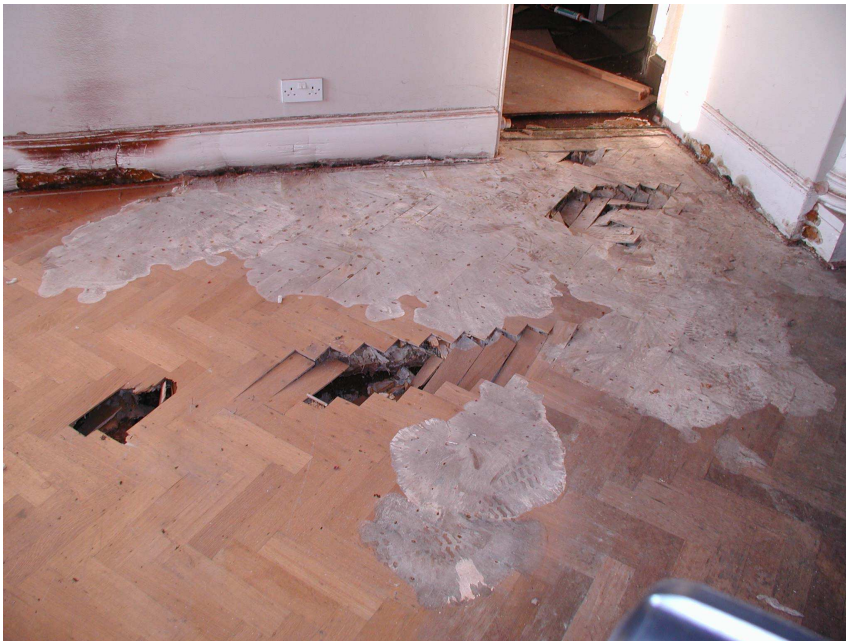
#### **Photograph 4**

**Dry rot mycelium growth to the timber floor, causing extensive structural decay to the floor.**

The following pictures illustrate the typical failures of timber in construction (see picture 4 and 5).

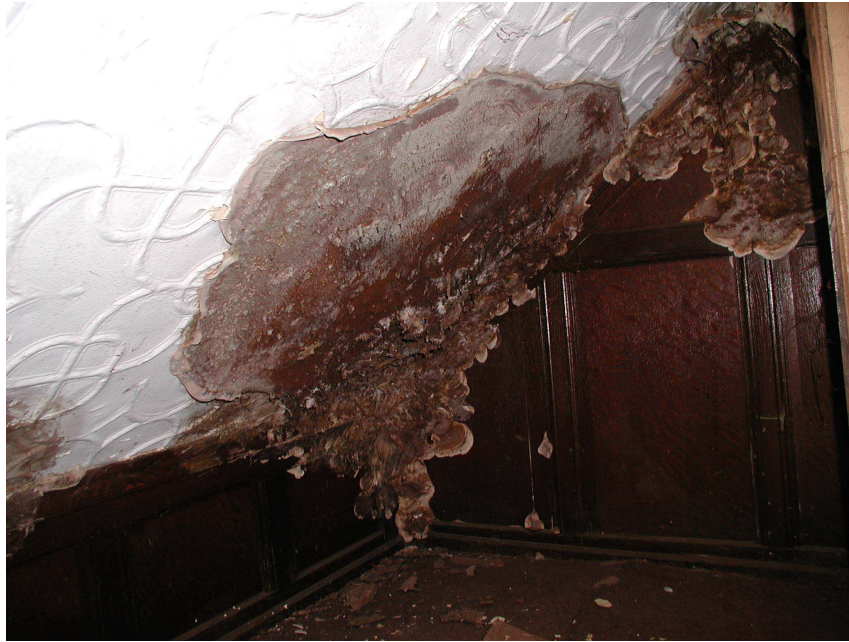
#### **Photograph 5**

#### **Dry rot fruiting body to the under stair void causing structural damage to the staircase and wall panelling**
